# Manhole Inspection Summary

Manhole # S33GG1001MH

Insp Date: **5/31/07 11:49 AM**

**Location** Address: **2 HADLEY SQ**

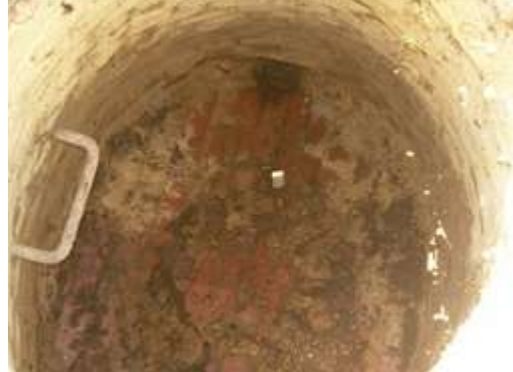
Top View

Channel debris.

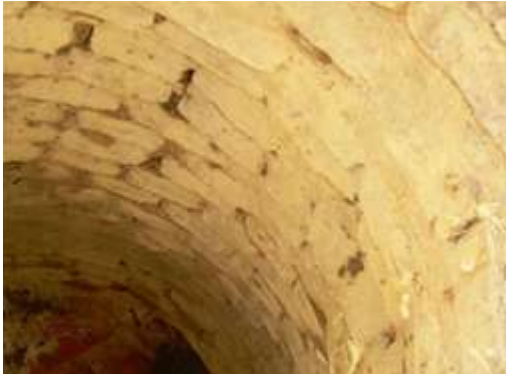
Defect

Infiltration: ☐ None ☒ **Joint** ☐ Cracks ☐ Mortar ☐ Roots ☒ **Wall**

Condition: ☐ Sound ☐ Cracked ☐ Root Intrusion ☐ Loose Brick ☒ **Deteriorated**

Infiltration: ☐ None ☐ Joint ☐ Cracks ☒ **Mortar** ☐ Roots ☐ Wall

Adjustment infiltration. Corbel deterioration and infiltration. Barrel infiltration.

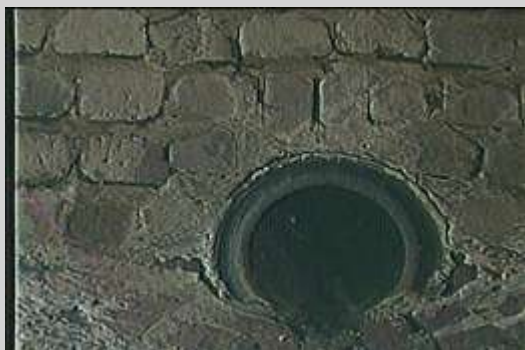
Pipe Out @ 12 O'Clock

Condition: ☐ Sound ☐ Cracked ☐ Root Intrusion ☐ Loose Brick ☒ **Deteriorated**

Infiltration: ☐ None ☐ Joint ☐ Cracks ☒ **Mortar** ☐ Roots ☐ Wall

Barrel deterioration and infiltration.
